Inspection Report
Minerals Regulatory Program
Report Date: June 1, 2005

Mine Name: The Rockland Mine
Operator or Permittee Name:
Miracle Rock Mining and Research
Permittee Mailing Address:
400 S. 200 E., Box 76, Emery, UT 84522

Permit number: M/015/040
Inspection Date: May 5, 2005

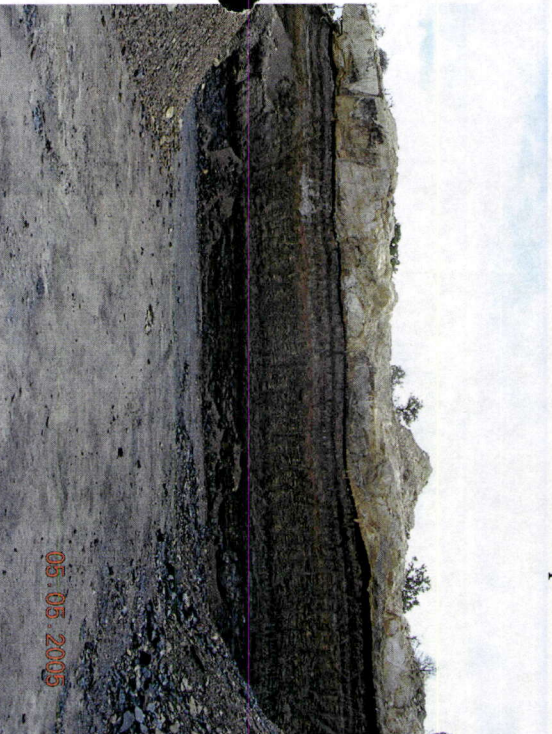
Photos 1 and 3 show where the operator has done some surface mining. I believe Mr. Taylor said this was done last fall. Photo 2 shows a product stockpile. When the material is first mined, it may not have the right physical or chemical characteristics, so it is placed on the surface where I assume there are some oxidation reactions.

Photo 1. Old surface mining area on the south side of the mine.

The reclamation bond and contract are for six acres. No additional surface disturbance is allowed.

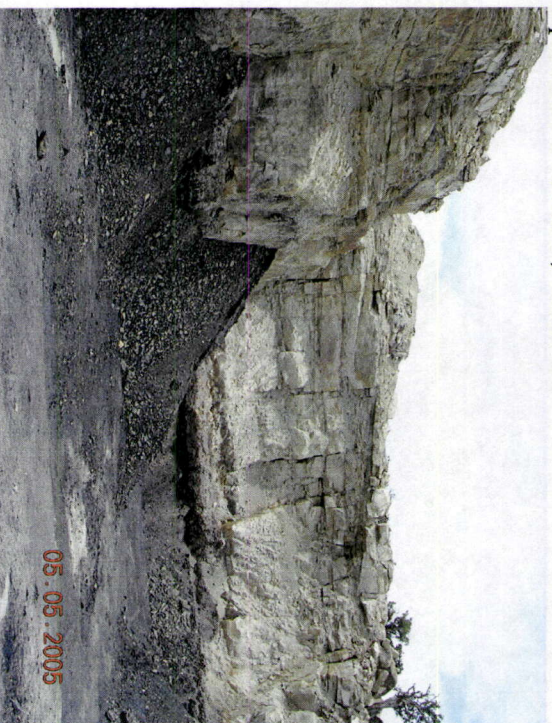
Photo 3. Surface mining area on the north side of the mine.

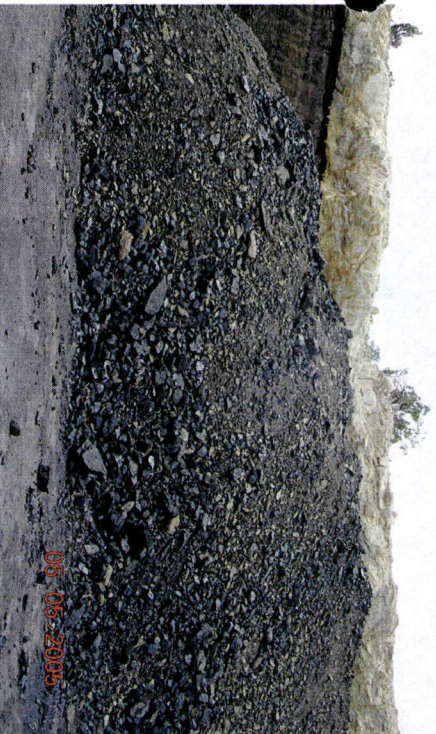
Photo 2. Weathering product stockpile.
